Manhole Inspection Summary

Manhole # S35EE_003MH

Location Address: **123 ST PAUL ST**

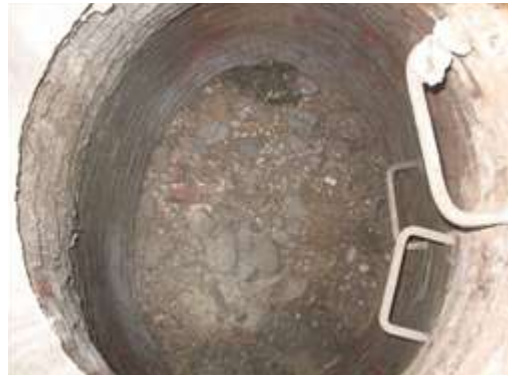
Top View

Channel debris.

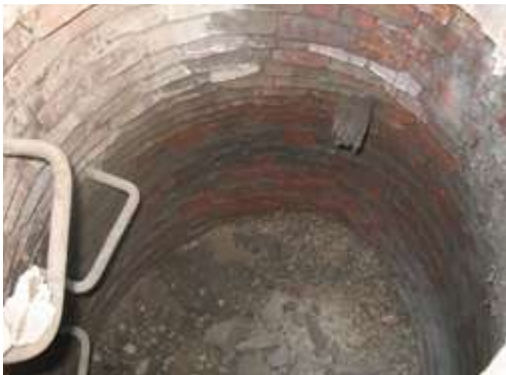
Defect

Frame leaks. Adjustment deterioration and infiltration. Corbel and Barrel infiltration - other side.

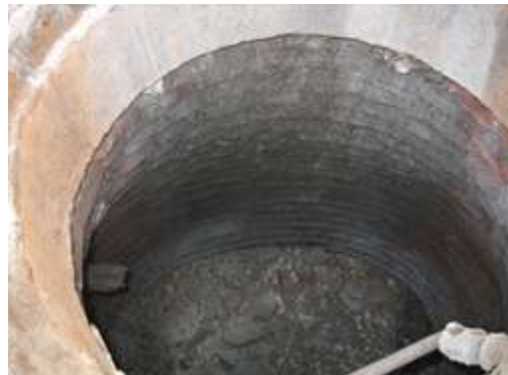
Defect

Frame leaks. Adjustment deterioration and infiltration. Corbel and Barrel infiltration.

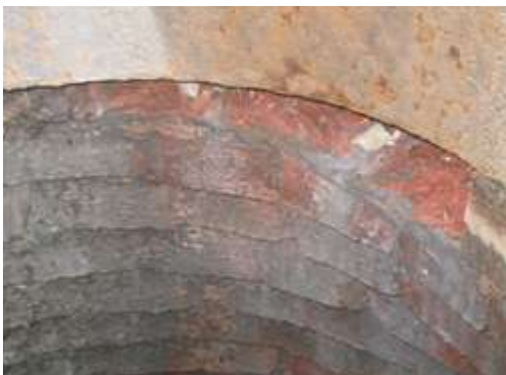
Defect

Frame leaks. Adjustment deterioration and infiltration. Corbel infiltration.

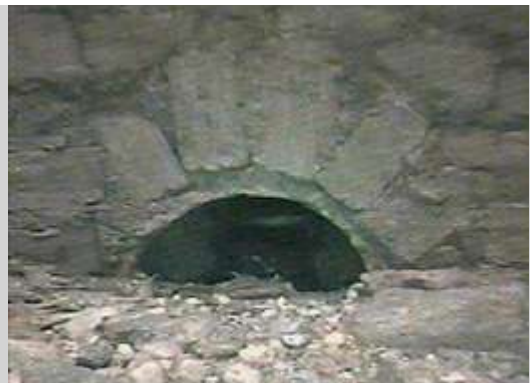
Pipe Out @ 12 O'Clock

Deposits: ☐ None ☒ **Mud** ☐ Sludge ☒ **Debris** ☐ Grease

Silt Depth: **4** (in.)

Deposits Extent: **Medium**

Infiltration: **Evidence**
